GEOTECHNICAL HAZARD ASSESSMENT

**Proposed Single-Family Residence
Lot 15 – 279 Tal Road
Lake Cowichan, BC**

May 28, 2025

File No.: E4424.01
Revision No.: 00
Prepared by: Tennes Hamre, P.Geo.
Reviewed by: Stuart Crossfield, P.L.Eng.,
P.Geo.

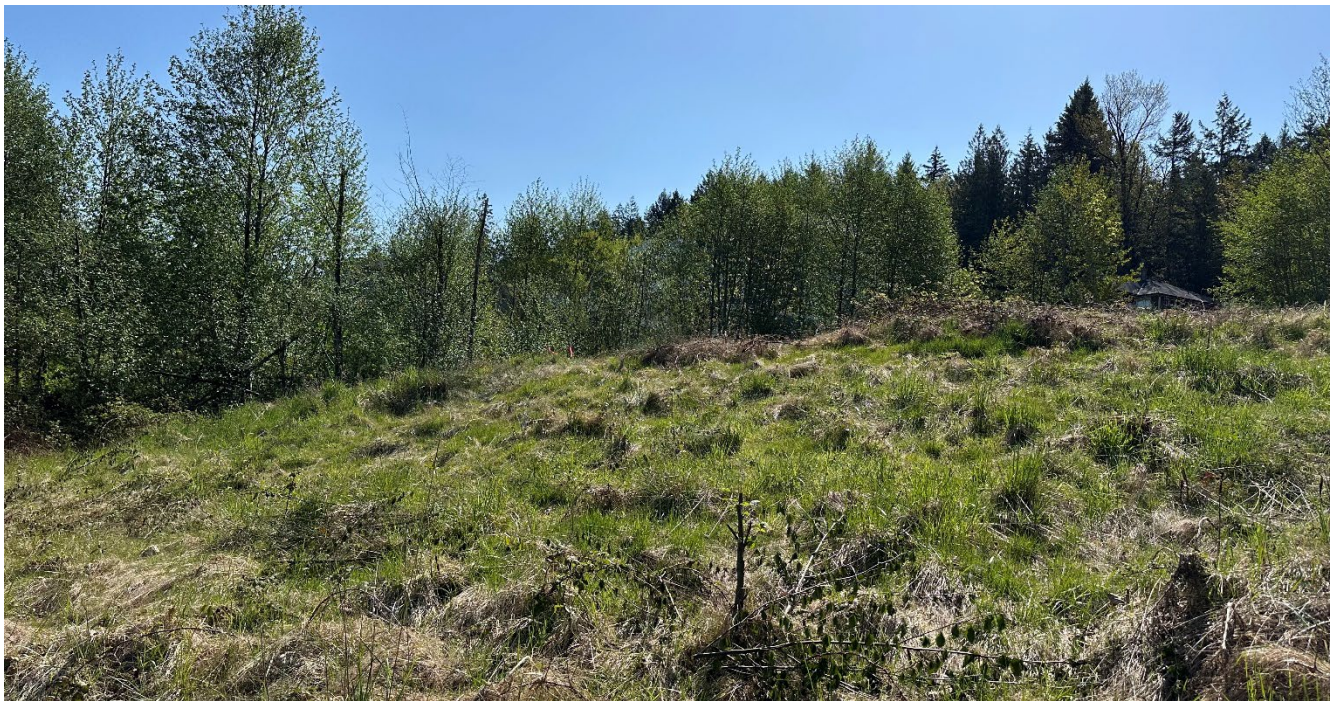
- d. The Property has been previously cleared and is currently vegetated with grasses across most of the area. The watercourse bank is vegetated with immature Red Alder, blackberries, grasses, and horsetail vegetation.

Photo 2.2.1 – General Property Area, looking southeast.

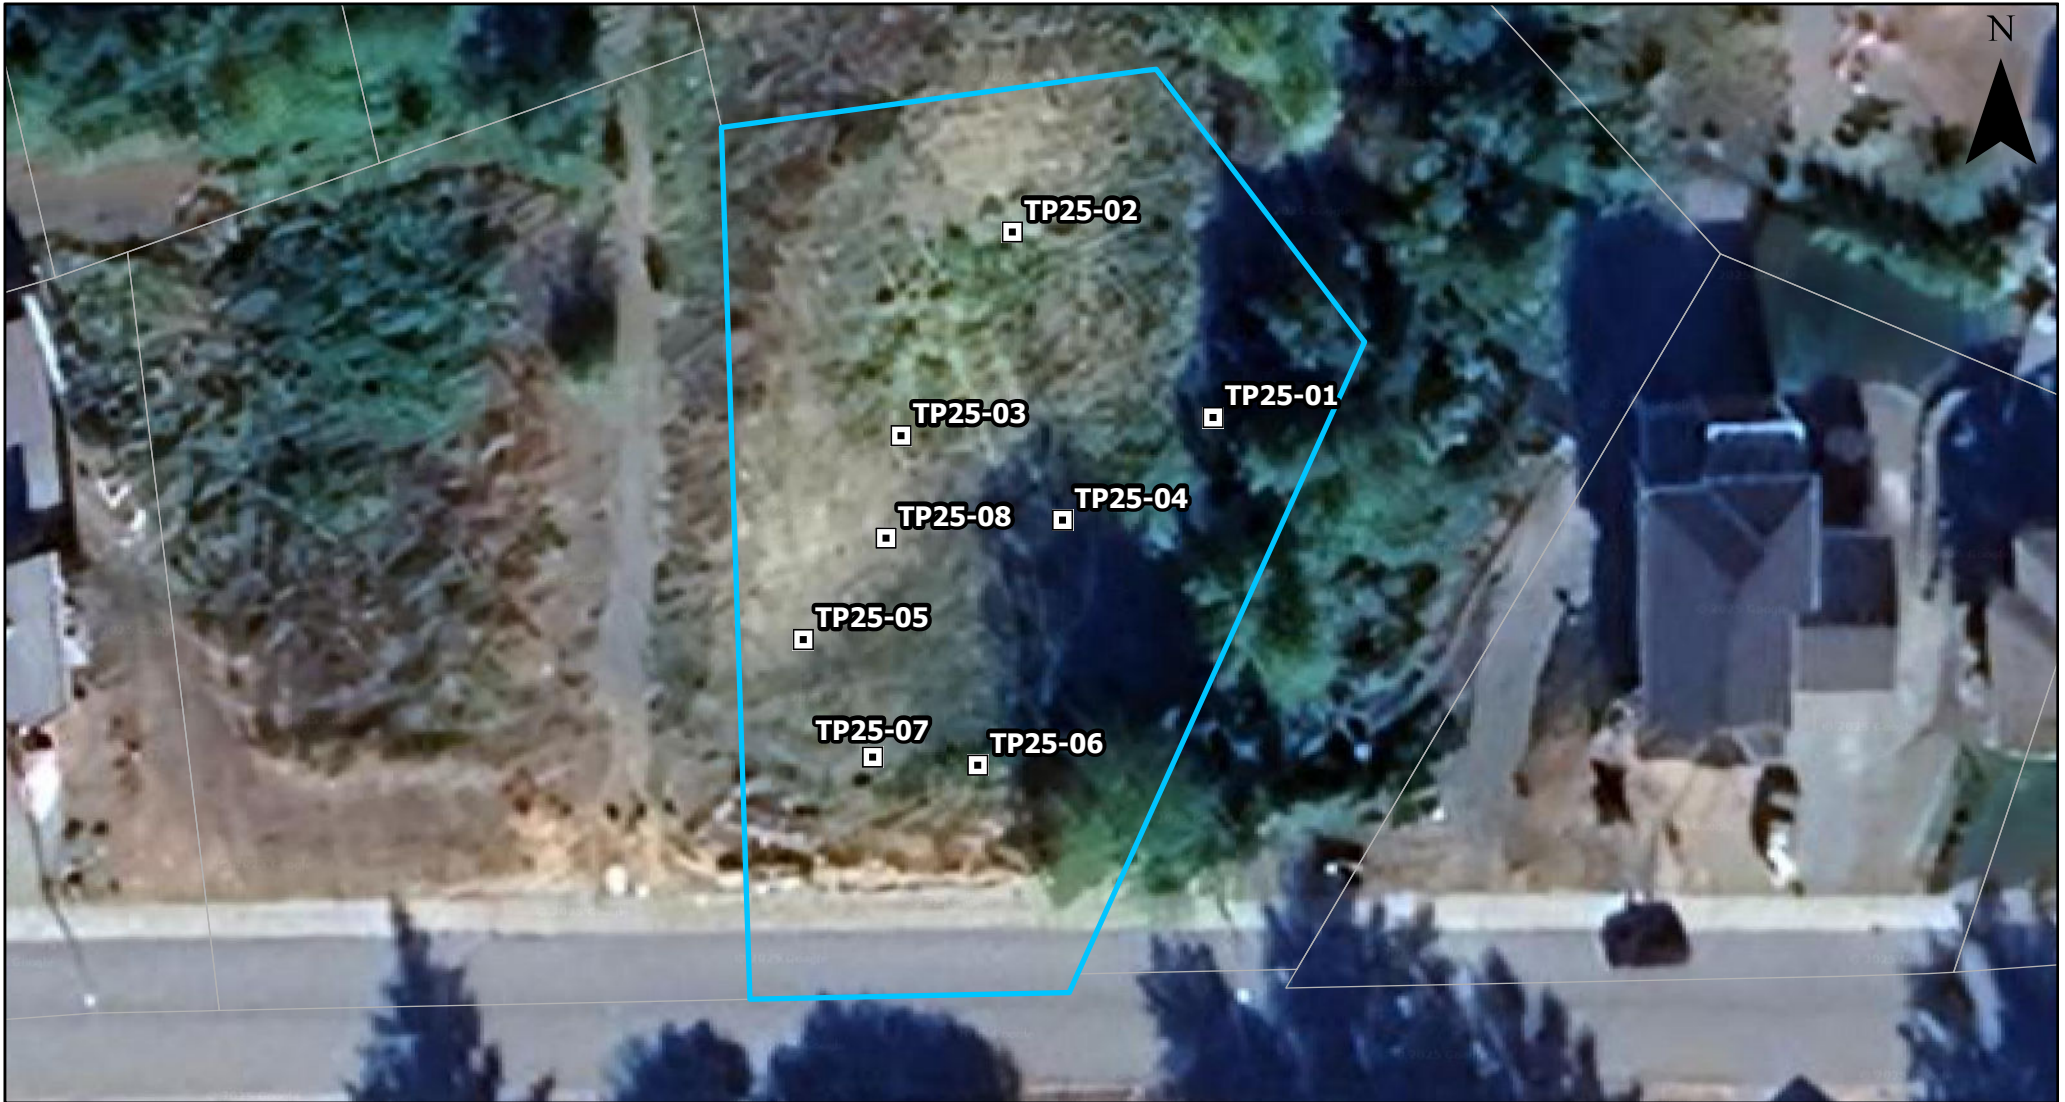
| | DRAWING TITLE Test Pit Site Plan | | Date: 2025-05-15 | Drawn By: TH | |

- b. A subsurface investigation was carried out on April 24, 2025, using a Deere 135 excavator. Eight TPs (TP25-01 to TP25-08) were advanced at locations across the Property to provide good lot coverage and characterize the subsurface conditions. The TPs were backfilled upon completion of the investigation.

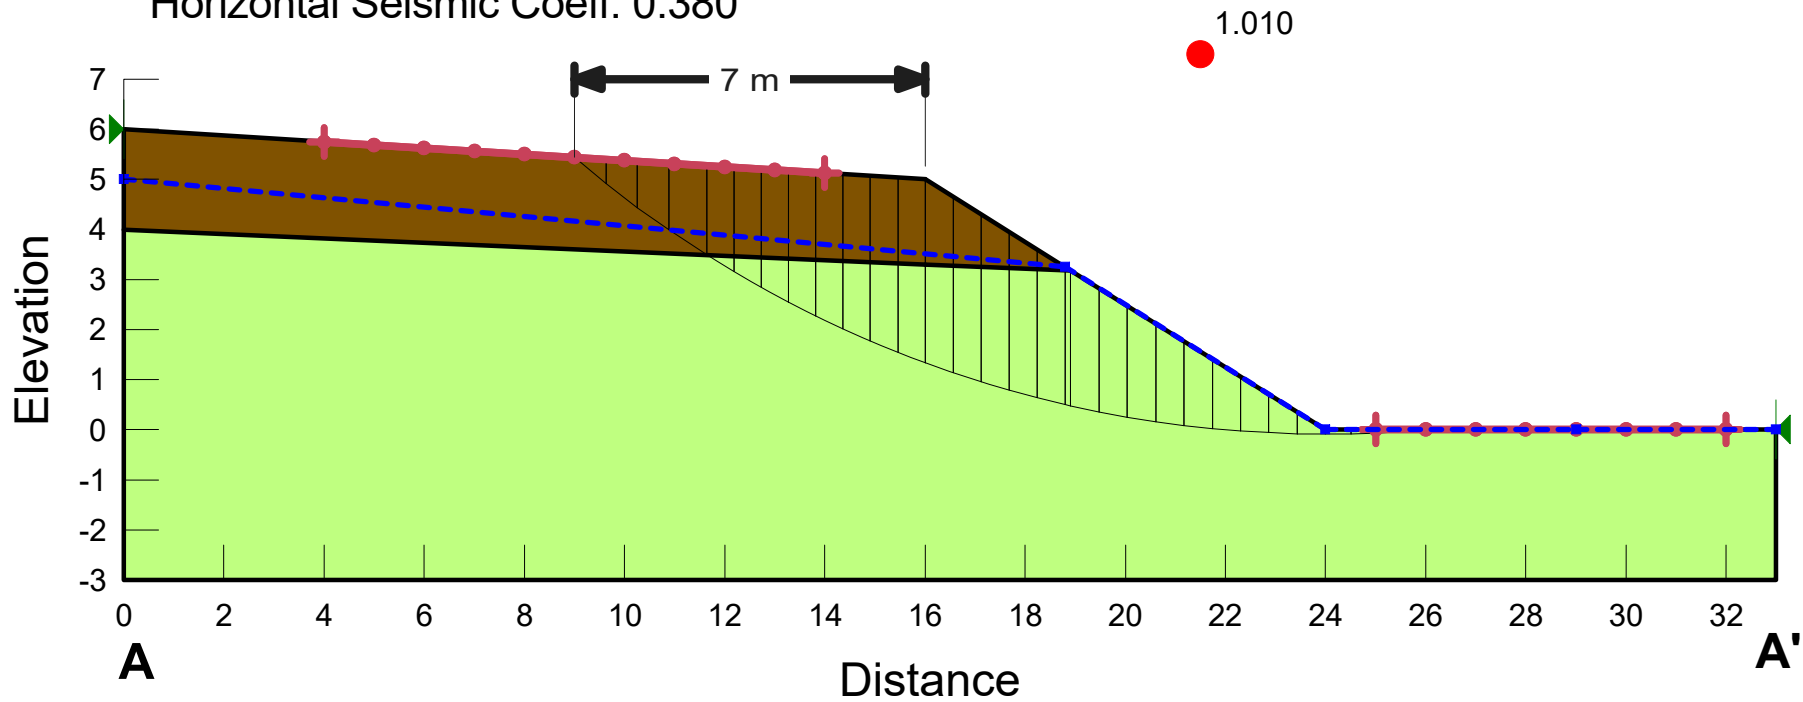
Horizontal Seismic Coeff: 0.380

| Section | Failure Scenario | Condition | Setback from Crest of Slope (m) |
|---|---|---|---|
| Section A-A' | Rotational Failure | Seismic | 7.0m |

- a. Based on slope geometry, subsurface conditions, interpreted mechanisms of slope movement described above, and the results of the slope stability analyses, we recommend a minimum setback of 7.0m from the crest of slope.

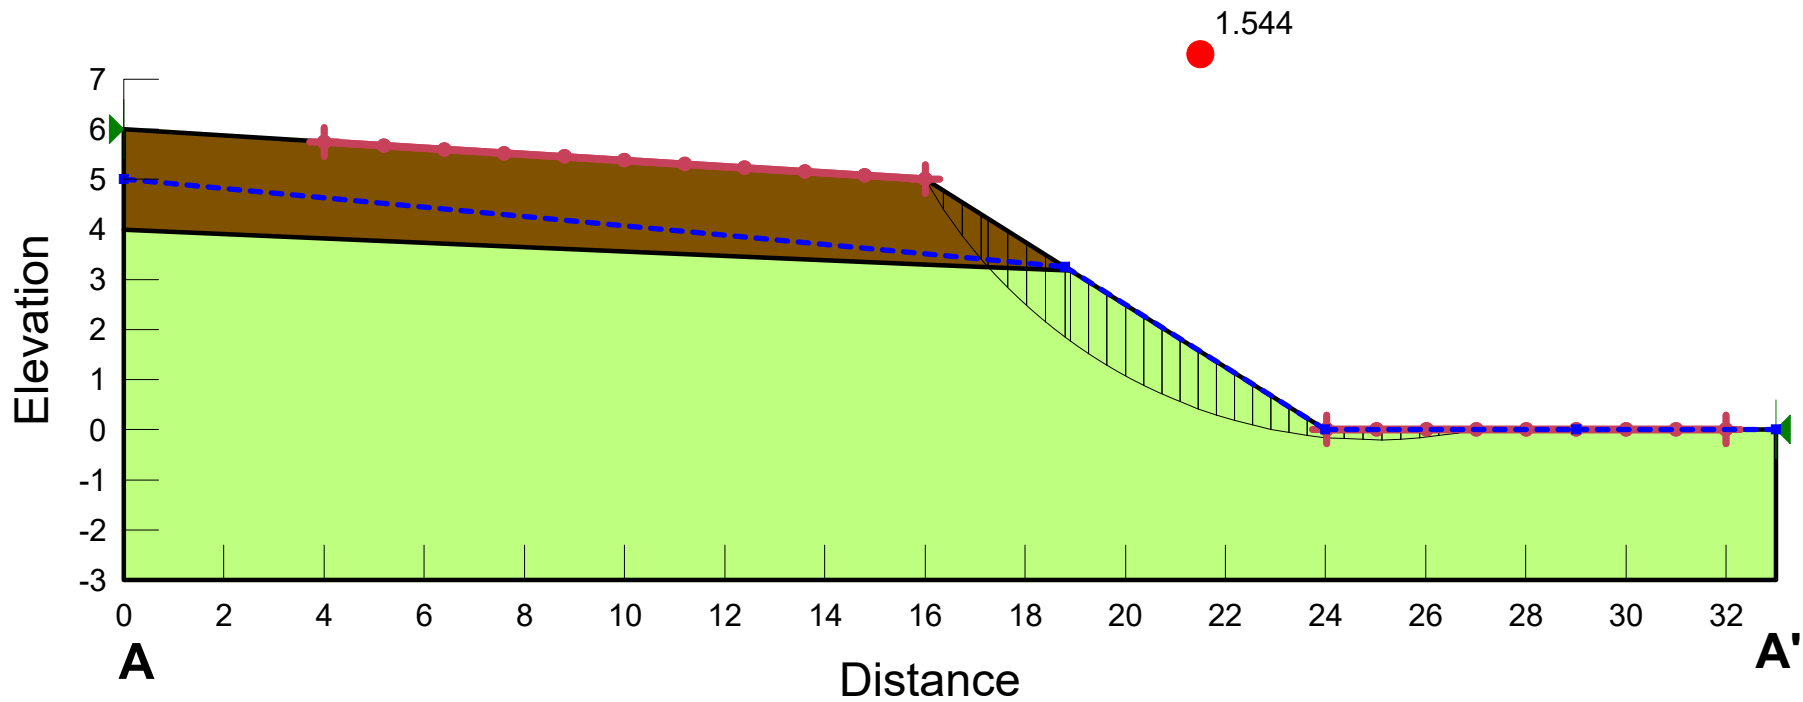
E4424
 Lot 15 - 279 Tal Road
 Static

| Section | Failure Scenario | Condition | Setback from Crest of Slope (m) |
|---|---|---|---|
| Section A-A' | Rotational Failure | Static | 0.0m |
