STAFF REPORT

TO: CHIEF ADMINISTRATIVE OFFICER
FROM: BRIGID REYNOLDS, CONSULTING TOWN PLANNER
SUBJECT: DP2026-01-01 AMENDMENT – SLOPES PHASE 6 V
MEETING DATE: APRIL 28, 2026
SUBJECT PROPERTY: REMAINDER LOT A, SECTION 6, RENFREW DISTRICT PLAN EPP103677 EXCEPT PART ON PLANS EPP104021 AND EPP109124 AND EPP138345 – P.I.D. 031-159-851

Wildfire Hazard Assessment

GEOTECHNICAL HAZARD ASSESSMENT

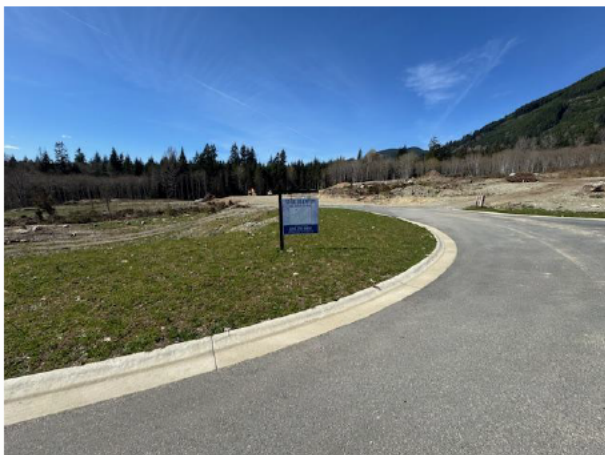
View of Phase 6 looking west.

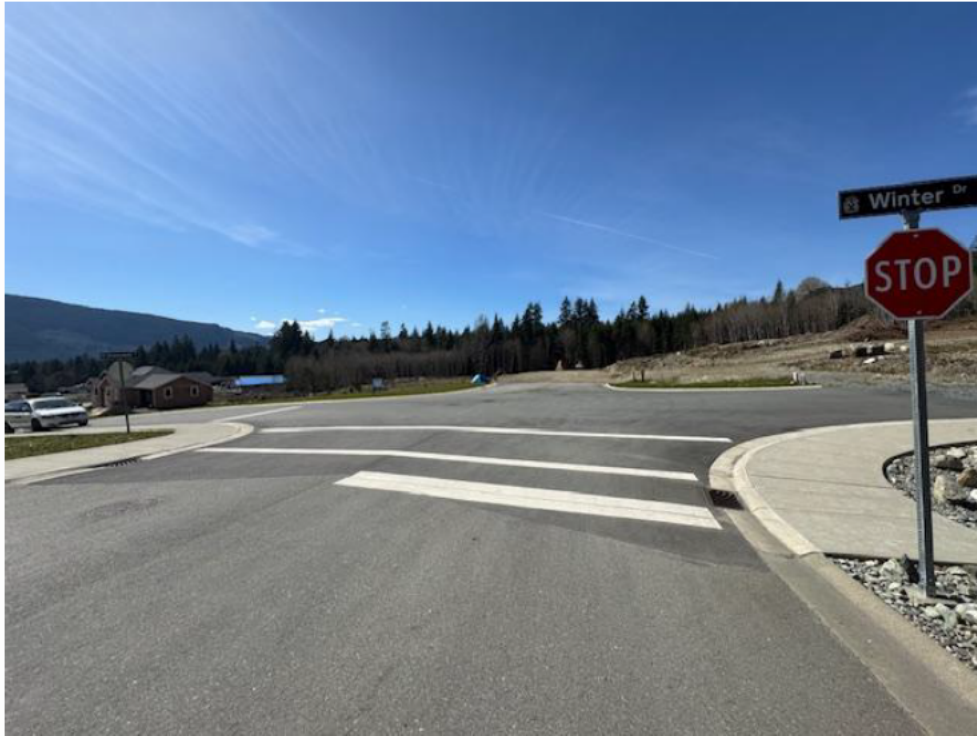
View of Phase 6 looking southwest from Winter Drive.

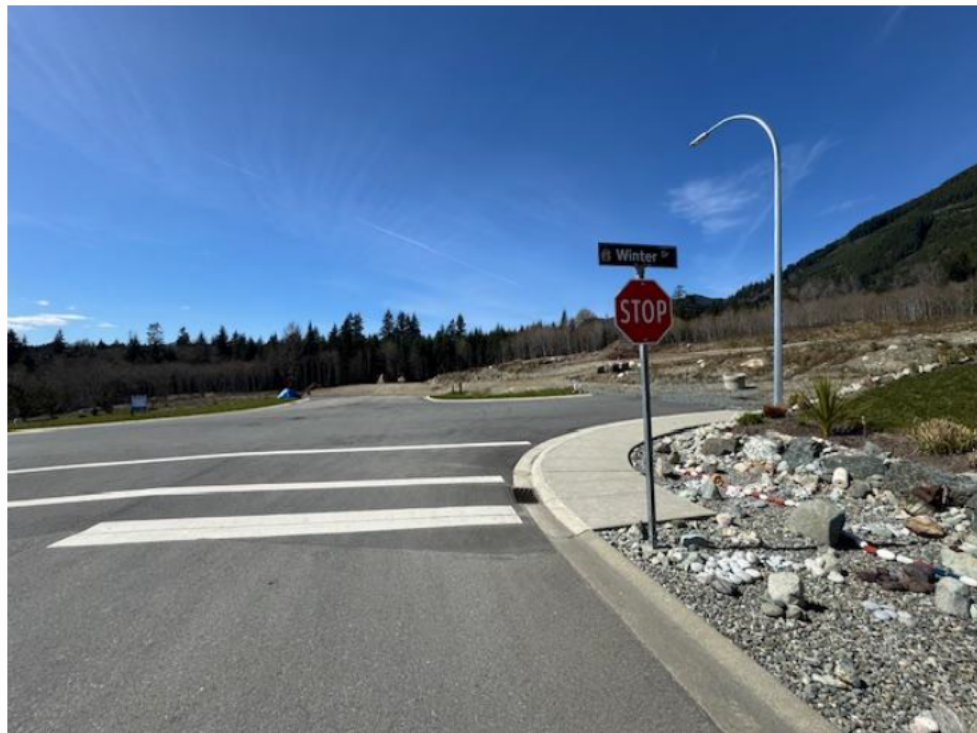
View of Phase 6 looking west from Winter Drive.

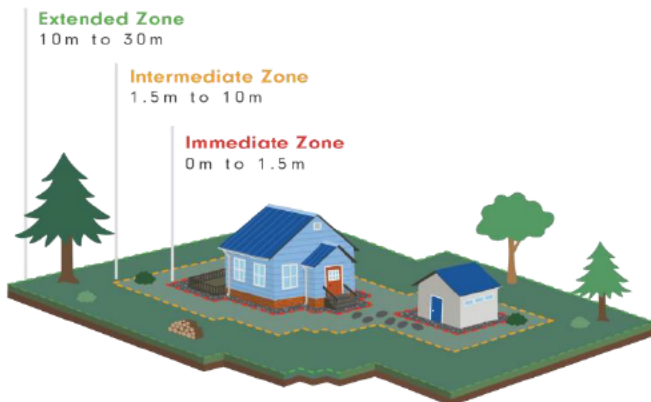
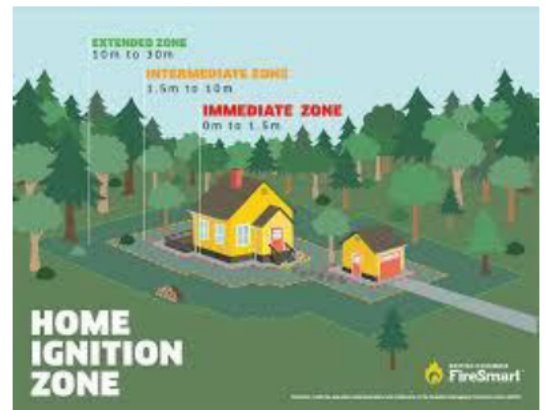
Firesmart Priority Zones

Extended Zone 2 (10-30 m): Where treatment in PZ 1 is not sufficient to significantly reduce the fire hazard due to fuel loading, extend the fuel modified area with a variety of thinning and pruning actions.

*Setback Zone distances may be extended depending on aspect, slope, fuel loading, etc.

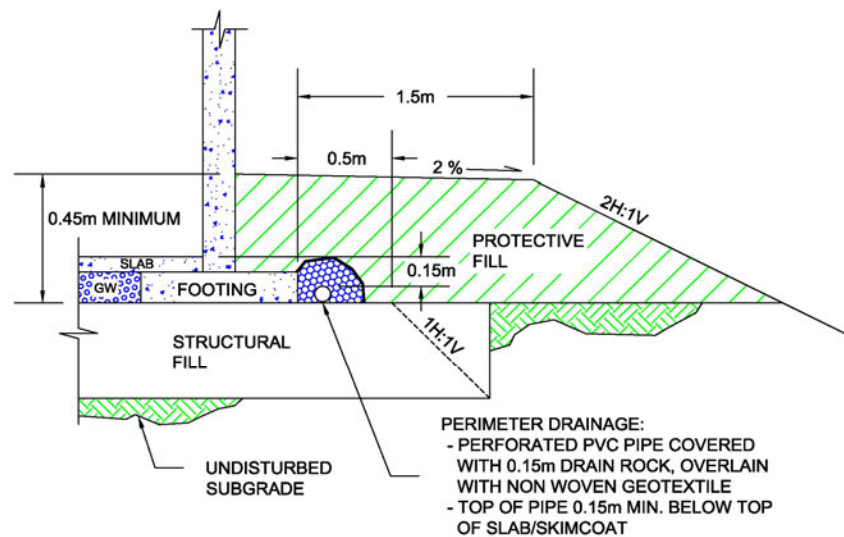
Figure 6.3 – Typical section for structural fill

- e. Compaction of fill should include moisture conditioning as needed to bring the fill to the optimum moisture content and compacted using vibratory compaction equipment in lift thicknesses appropriate for the size and type of compaction equipment used.

- f. A general guideline for maximum lift thickness is no more than 100mm for light hand equipment such as a “jumping-jack,” 200mm for a small roller, and 300mm for a large roller or heavy (>500 kg) vibratory plate compactor or a backhoe mounted hoe-pac or a large excavator mounted hoe-pac, as measured loose.
- g. It should be emphasized that the long-term performance of foundations, slabs, and pavements is highly dependent on the correct placement and compaction of underlying structural fill. Consequently, we recommend that structural fill be observed and approved by the Geotechnical Engineer. This would include approval of the proposed fill materials and performing a suitable program of compaction testing during construction.

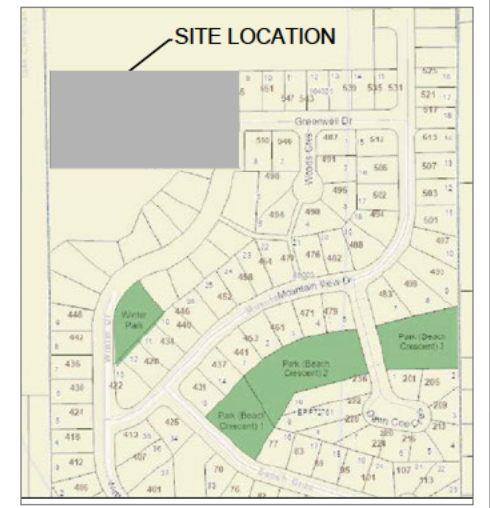
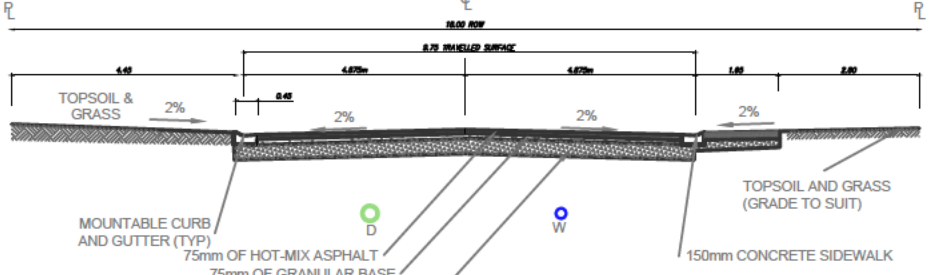
TOWN OF LAKE COWICHAN		
PROJECT:	THE SLOPES PHASE 6	
SHEET TITLE:	REMAINDER LOT A PLAN EPP103677	
COWICHAN ENGINEERING SERVICES LTD. 6468 NORCROSS ROAD DUNCAN, BC cowichanengineering@shaw.ca	DRAWN: CW/TE CHECKED: CW SCALE: 1:750	DATE: APRIL 28 2025 FILE: 1537-C DWG: 1537-C-PLA

- CONSTRUCTION NOTES:**
- (A) LOTS 2-7 TO HAVE DRAIN ROCK PITS THROUGH SRW TO THE SOUTH
 - (B) 1200mm EXFILTRATION MANHOLE
 - (C) EXTEND ROAD AS PER SECTION A TO TURNAROUNDS
