## STAFF REPORT

**TO:** CHIEF ADMINISTRATIVE OFFICER  
**FROM:** BRIGID REYNOLDS, CONSULTING TOWN PLANNER  
**SUBJECT:** DP2026-04 – 464 MOUNTAIN VIEW CR  
**MEETING DATE:** JANUARY 27, 2026  
**SUBJECT PROPERTY:** LOT 23, SECTION 6, RENFREW DISTRICT, PLAN VIP86003 (PID 027-742-679)

# GEOTECHNICAL HAZARD ASSESSMENT

# WILDFIRE HAZARD ASSESSMENT FOR 464 MOUNTAINVIEW ROAD

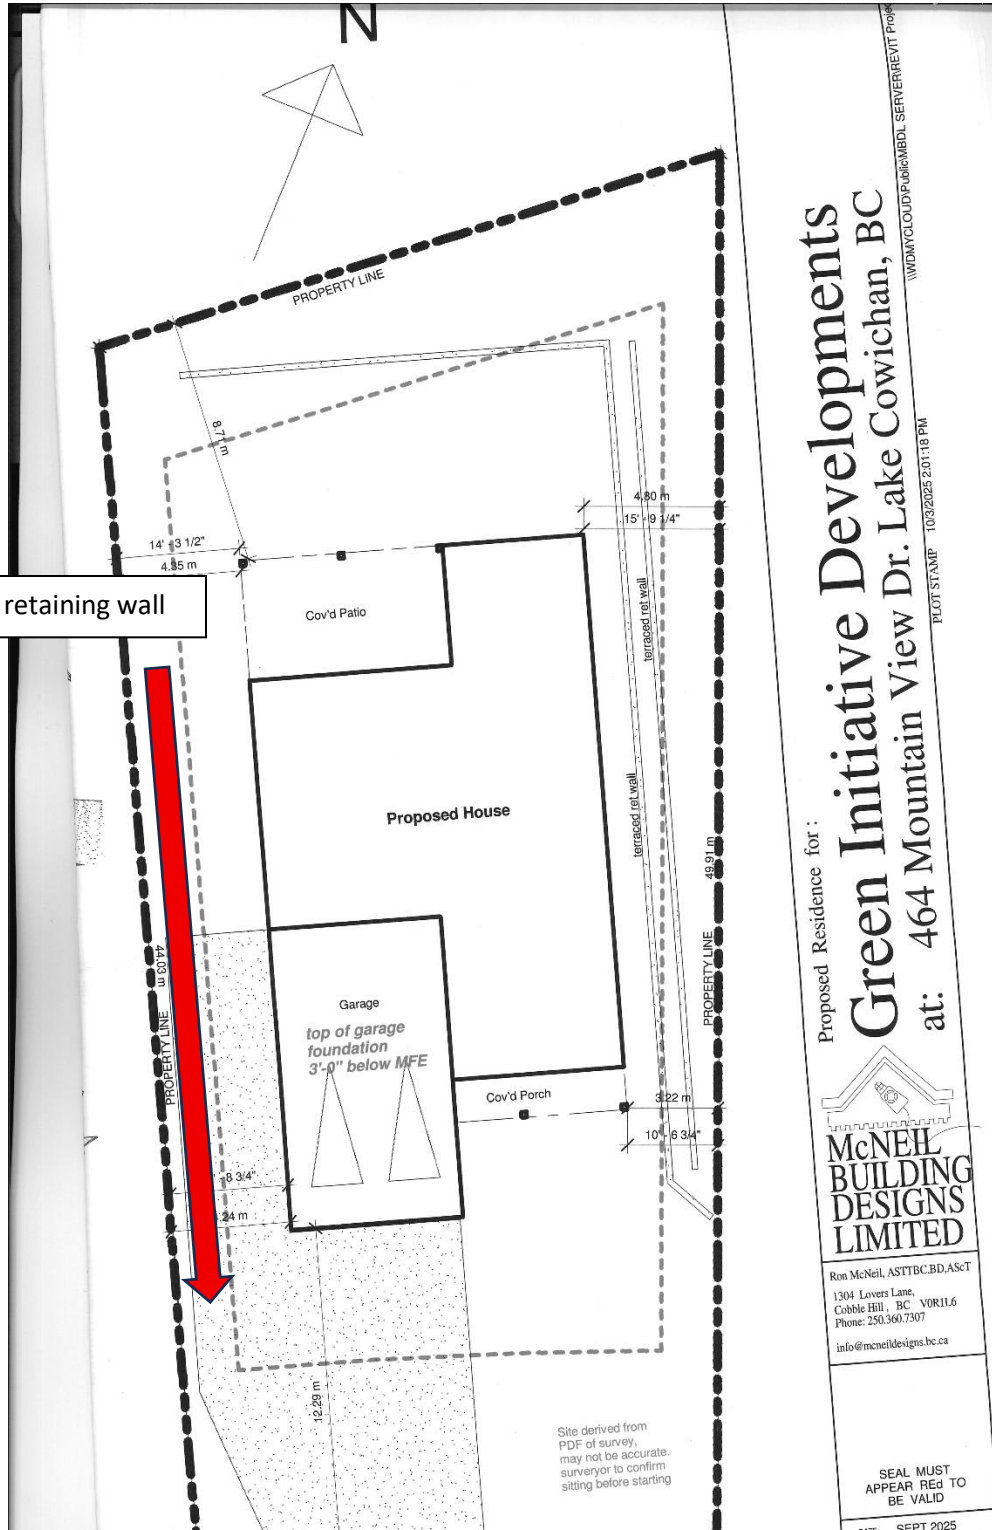
**ATTACHMENT 1  
SITE PLAN**

A 1.8 m tall stacked rock wall was constructed along the west property line without pre-approval from the Town and was not designed by the Geotechnical Engineer. The geotechnical report states these types of walls can be a rock fall hazard for downslope properties. The report states that stacked rock walls shall have a level (flat) 'no-build' rock fall zone along the based of the wall with a minimum lateral distance equal to the wall height. This stacked retaining wall is not shown on the site plan but its general location has been added by the planner.

Unpermitted 1.8 m retaining wall

The geotechnical engineer has confirmed that this stacked retaining rock wall does meet the requirements. The applicant has stated that this wall will be removed prior to any other land alteration. Approval to remove this retaining wall forms the first phase of this development permit.

1. Prior to issuing DP2026-04 the applicant shall provide additional requested information regarding the Wildfire Hazard Assessment report prepared by Inwood Forestry.
2. Prior to any land alteration and building permit issuance:
  - a. Register a section 219 covenant including a save harmless clause and the Geotechnical Hazard Assessment prepared by Lewkowich Engineering, dated January 8, 2026 on the certificate of title.
  - b. Implement sediment and erosion control measures to prevent sediment from leaving the site and entering the Town's stormwater system.
3. Following confirmation of the registration of the Section 219 covenant, the first land alteration action shall be to remove stacked retaining wall along the west property line.
4. All development shall be in accordance with
  - a. Attached site plan
  - b. Any retaining wall over 2.0 m in height are not permitted.

- c. All recommendations detailed in the Geotechnical Hazard Assessment, prepared by Lewkowich Geotechnical Ltd. dated January 8, 2026 and specifically any retaining wall over 1.2 m in height shall be designed by a geotechnical engineer.
  - d. All recommendations detailed in the Wildfire Hazard Assessment, prepared by Inwood Forestry Services, dated December 8, 2025.
5. Prior to occupancy permit issuance:
- a. Stormwater requirements require installation of two storm-tec chambers with connections to the storm IC connection. Inspection is required before storm-tec chambers are backfilled.
  - b. Submit schedule B letters of assurance from the Geotechnical Engineer for house construction and any retaining wall over 1.2 m in height.

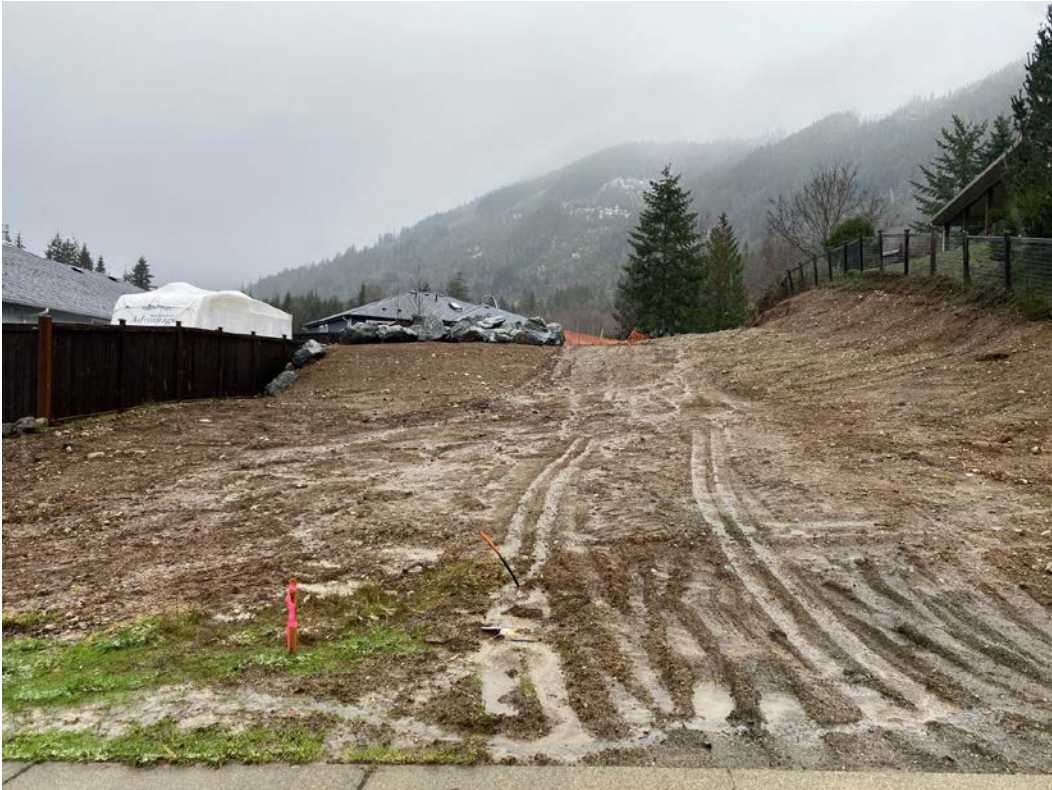
Figure 2.4.1 – Overview of Property from Mountain View Road, looking north.

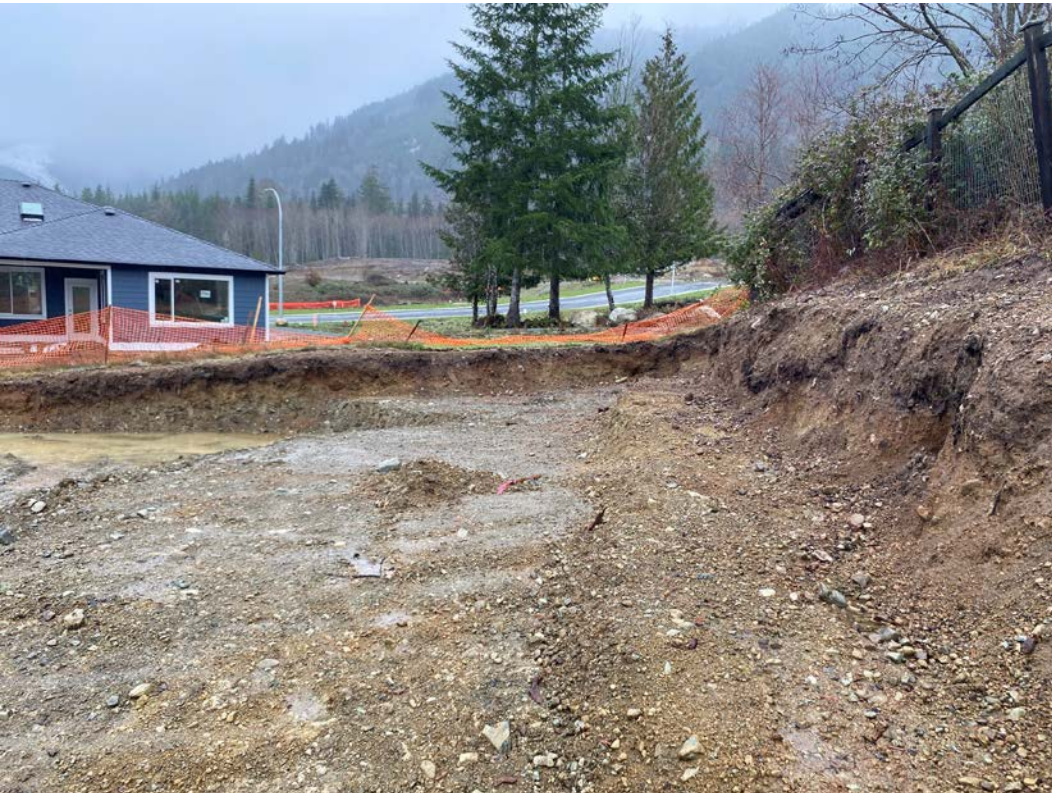
- b. Based on surficial geology, observed conditions, and LEA experience in the immediate area, we note subsurface soil conditions consist of thin deposits of surficial granular overburden, overlying dense to very dense till-like soil (i.e., silty sand and gravel, cobble) within approximately 0.5 to 1.0m from the ground surface.

Figure 2.4.2 – Rear of Property showing existing excavations to dense till soils, looking north.

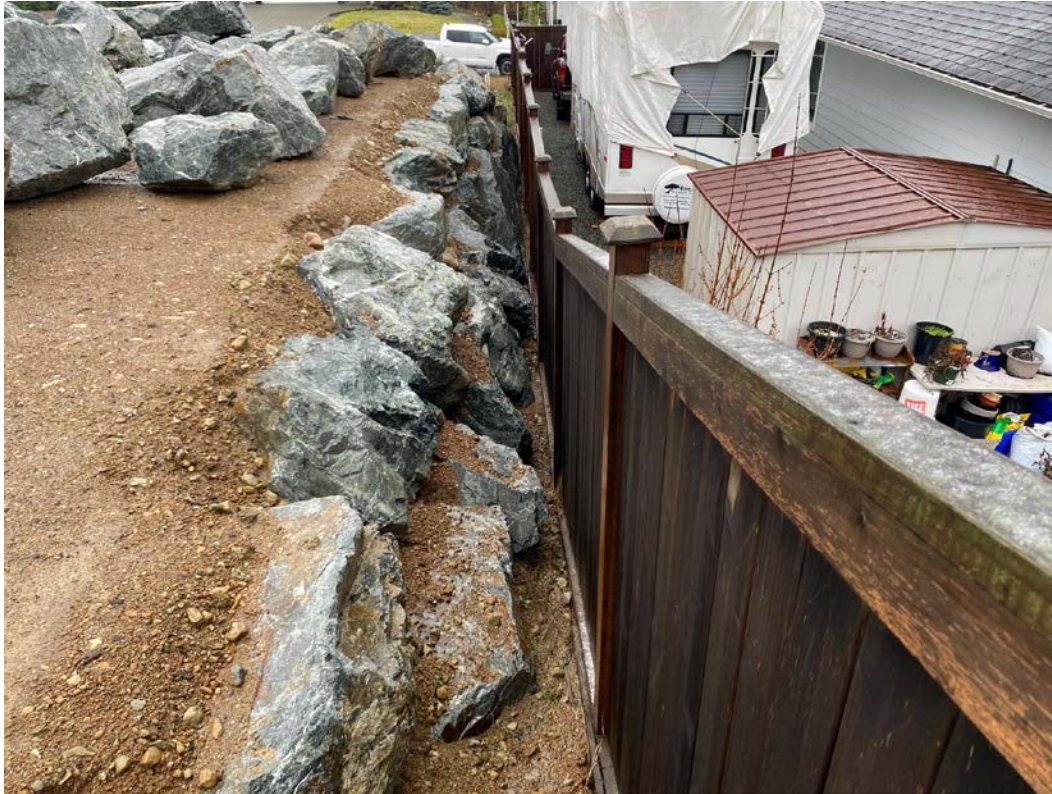
- c. We observed a 1.8m tall stacked rock wall along the west side of the Property, supporting undocumented reworked fills, comprised of naturally deposited till-like soils cut out from the east side of the property. Small stockpiles of fill were observed including large boulders. The depth to competent till-like soil may be greater in areas of fill. See Figures 2.4.1 to 2.4.3 for general site photos below.

**Figure 2.4.3** – West Property boundary showing 1.8m stacked rock wall and fill above, looking south.

- e. Any proposed retaining walls exceeding 1.2m in height must be designed by a Structural and/or Geotechnical Engineer. Setbacks and/or deepened foundations are generally required for buildings in proximity to downslope retaining walls. As a rule of thumb, buildings should be set back a minimum of 1.5x the wall height from the top of wall. This applies to the existing stacked rock wall along the southern property limit.

- f. Stacked rock walls could present a rockfall hazard for downslope development. Therefore, all stacked rock walls shall include a level (flat) “no-build” rockfall zone along the base of the wall with a minimum lateral distance equal to the wall height.

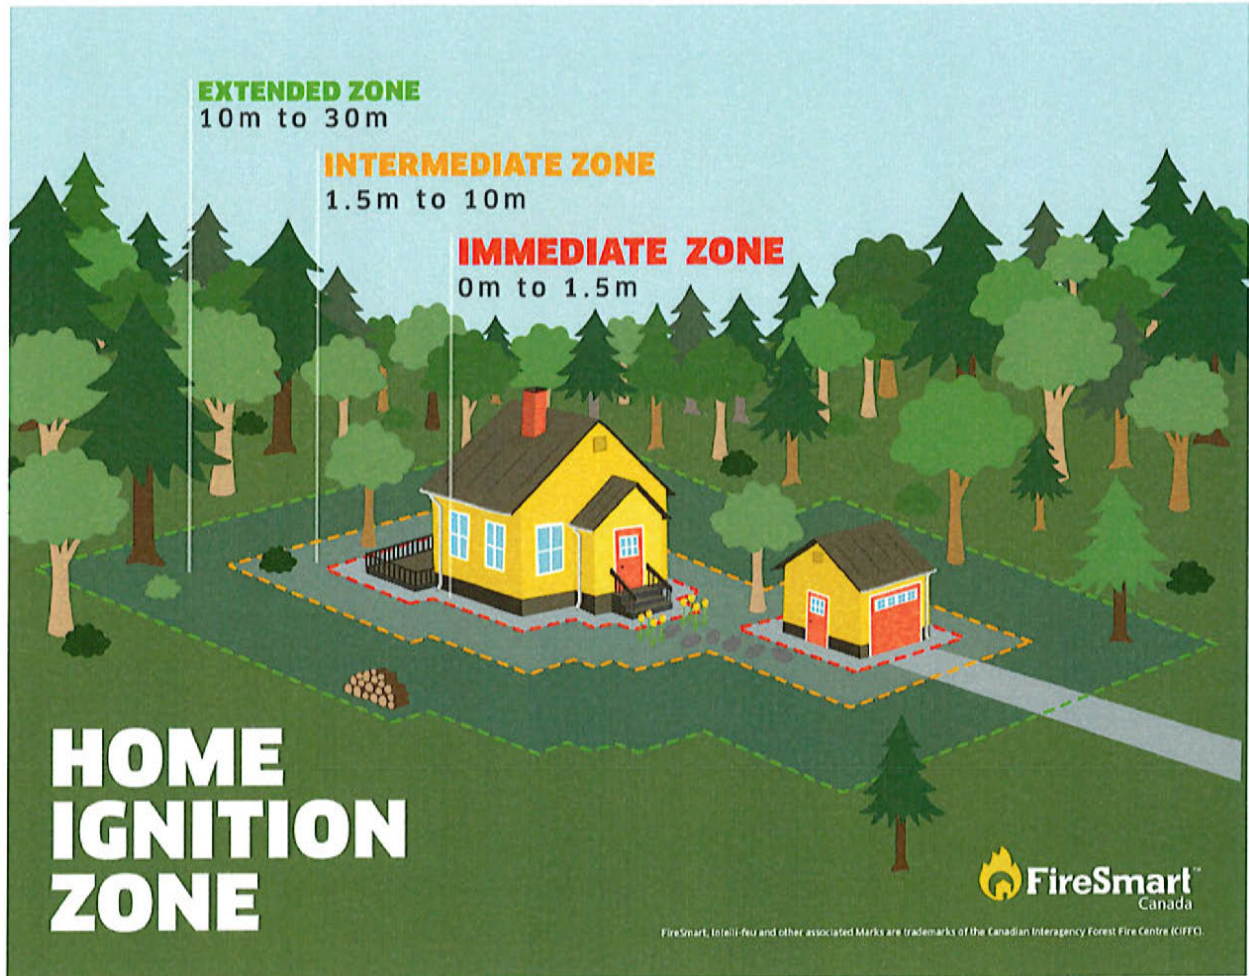
Inwood Forestry Services Ltd. conducted a site visit on December 6, 2025 to assess the site and wildfire hazards. From the proposed build site, the extended zone (10-30m from proposed dwelling) was the focus of this inspection. This is based on criteria by FireSmart Canada (see figure 1 and 2).

Figure 1: Home Ignition Zone Assessment from Firesmart Canada, showing Immediate, Intermediate and Extended zones.

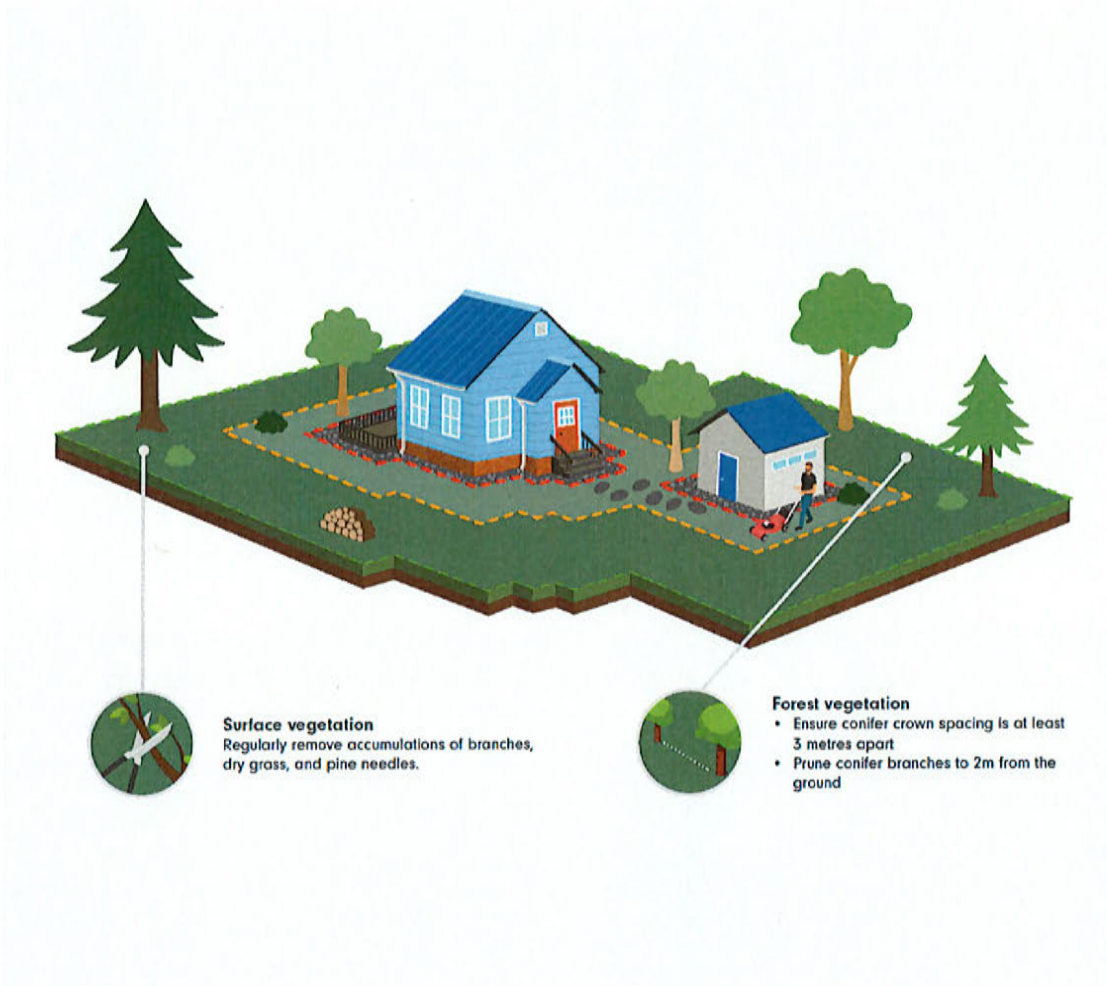
The focus in the Extended Zone is not to eliminate the possibility of fire, but to reduce its intensity.

Figure 2: Extended zone recommendations according to FireSmart Canada.

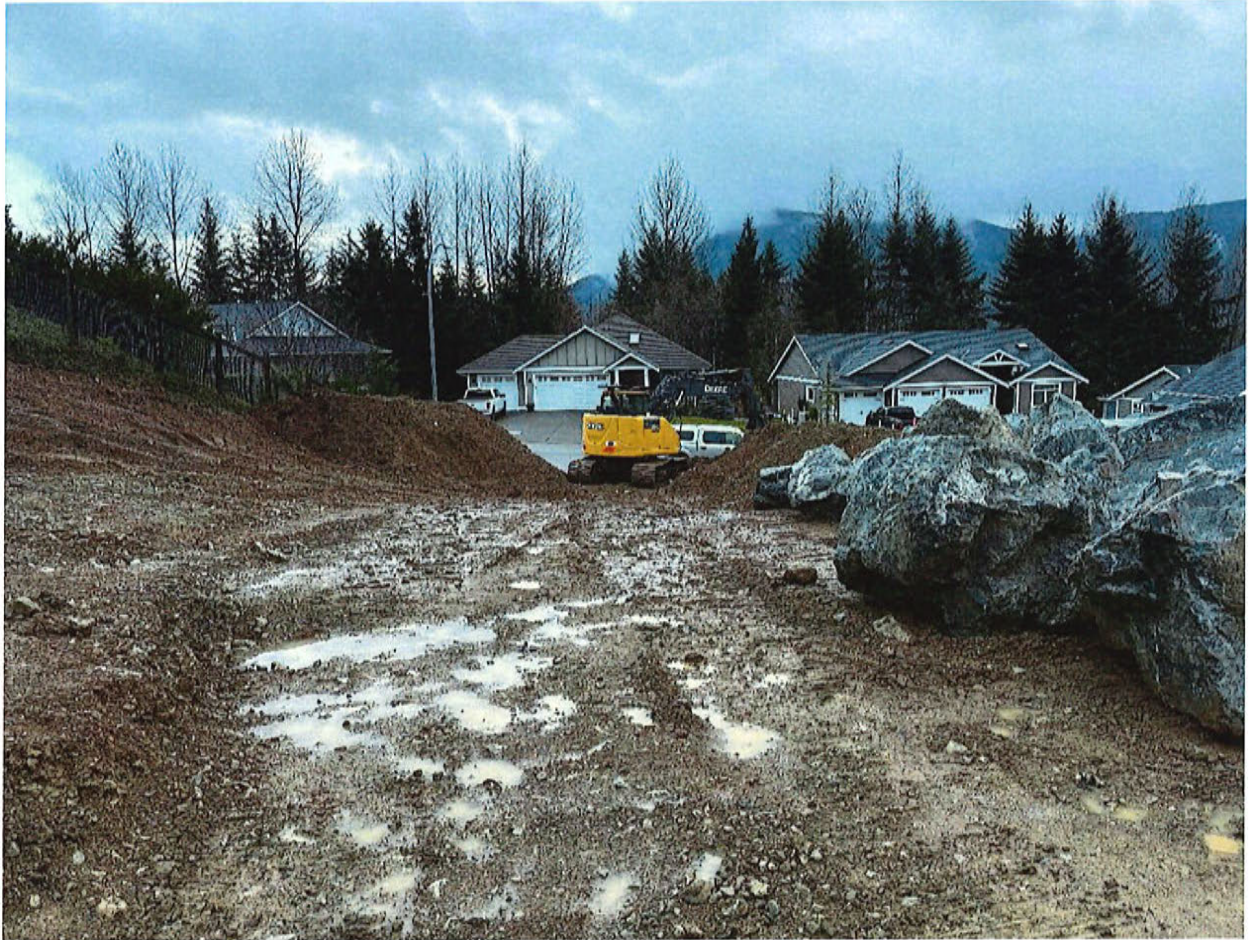
Most of the surface vegetation on this site has been removed to accommodate for the proposed dwelling (see figure 4 and 5). It is recommended, that any grass planted in the future be kept to a height of 10cm or less according to FireSmart Canada recommendations.

*Figure 4: Vegetation cleared from lot for construction purposes.*

Due to the fact that the vegetation has been cleared from this lot, no work is needed at this time to abate the fire hazard at 464 Mountainview Rd. The following are recommendations for future lot development and planning.

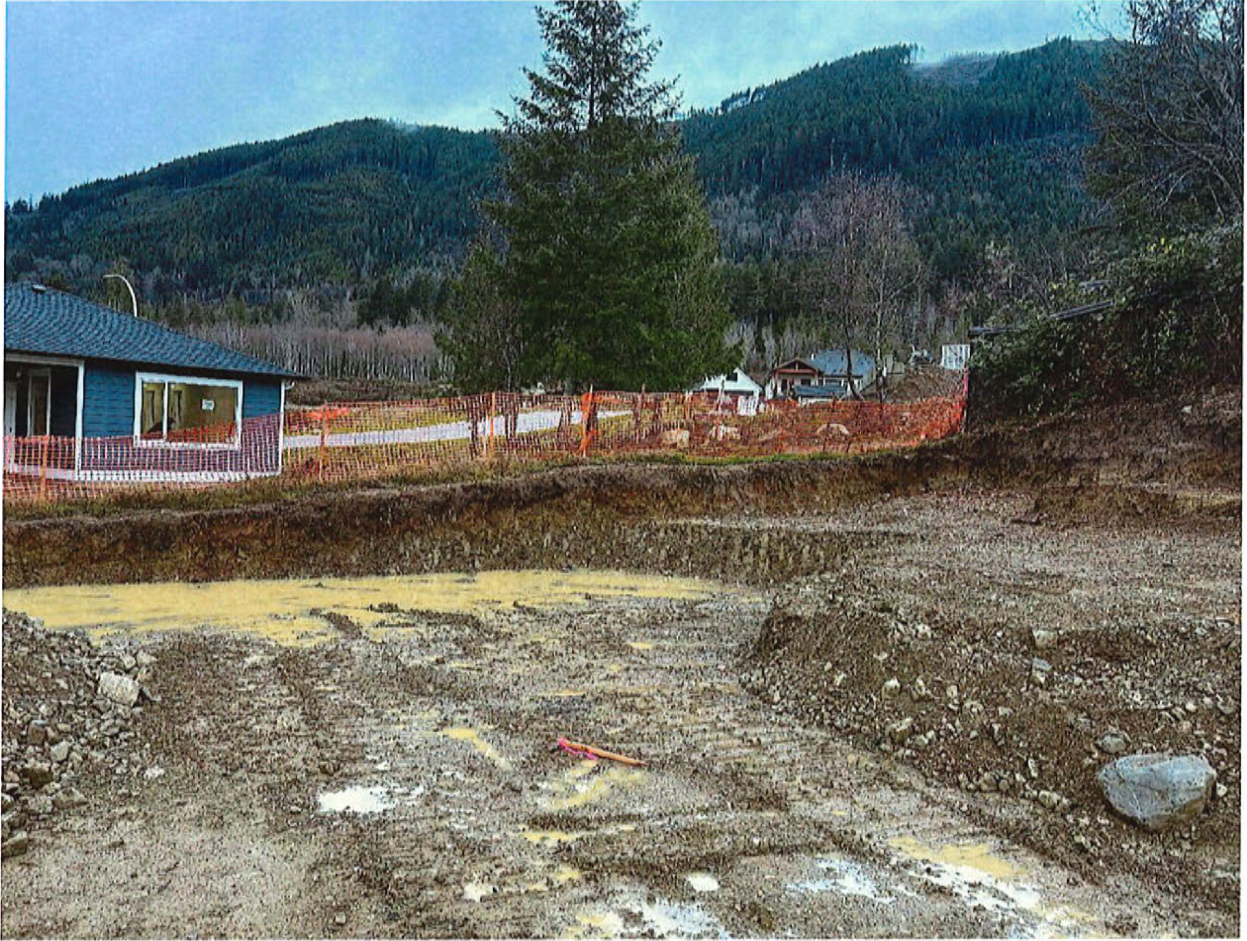
*Figure 5: Vegetation cleared from lot for construction purposes.*
