AQUAPARIAN

February 15, 2023

**RE: Environmental Assessment for New Retaining Wall
62 Gordon Road, Cowichan Lake, Cowichan River**

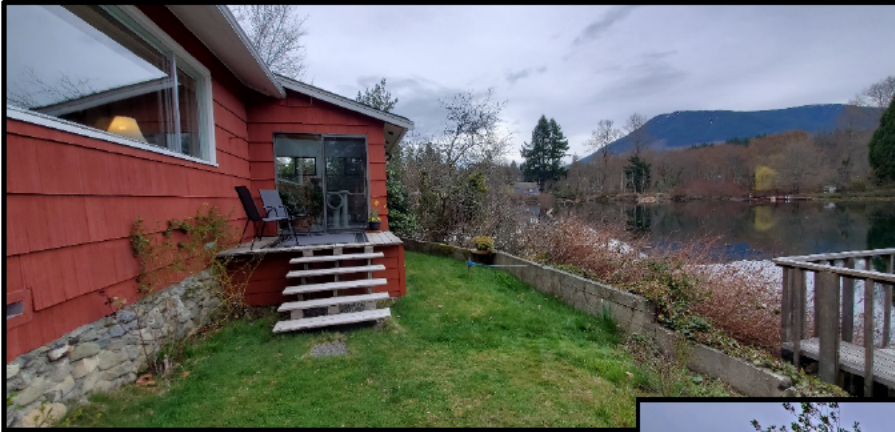
View looking east along back of 62 Gordon Rd property. Small retaining wall to be removed. Yard is as little as 1.4m wide from house and as wide as 2.6m. Corner of house sloughing. Water last year (Nov 2021) reached foundation of house.

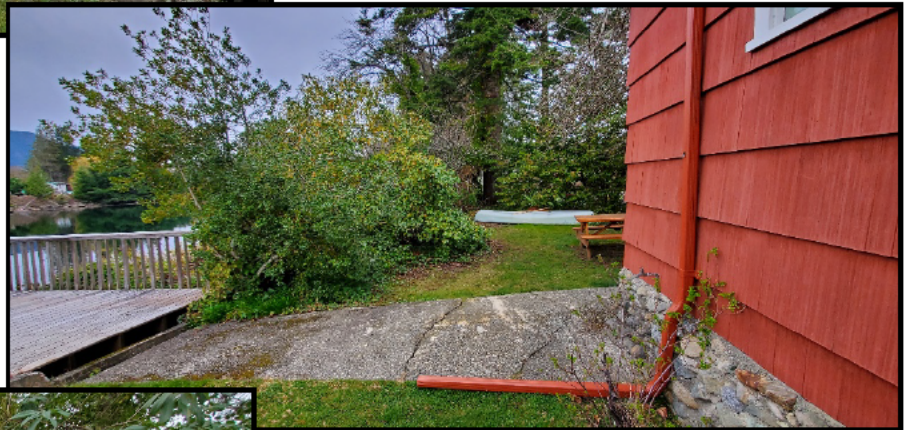
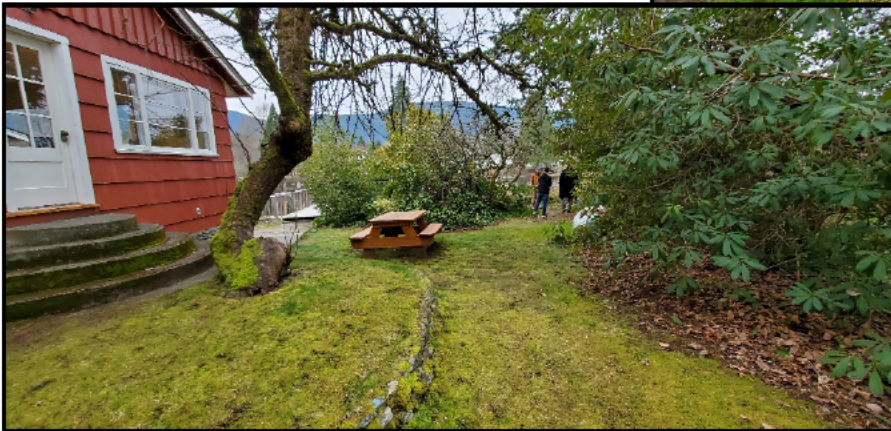
View looking west at back of subject property. Cracked concrete side walk leading to wood deck.

View looking south towards back of property. 15m Riparian DPA to include much of house in it.

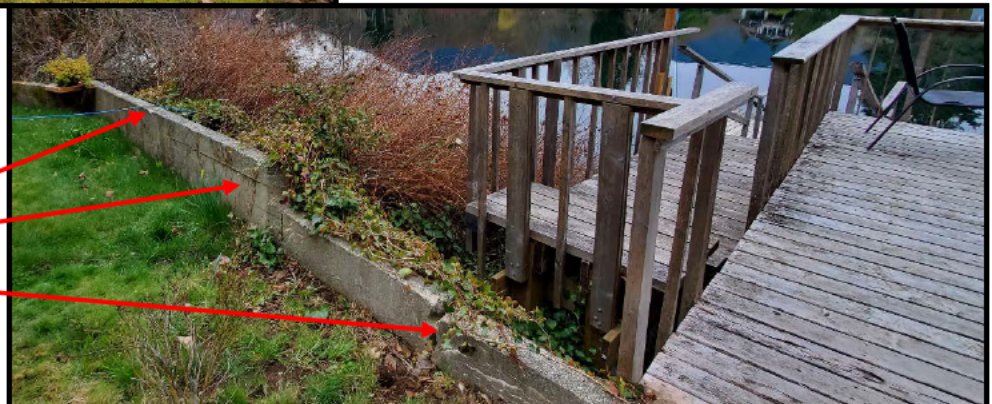
Image shows 8" thick concrete retaining wall with cracks and separations.

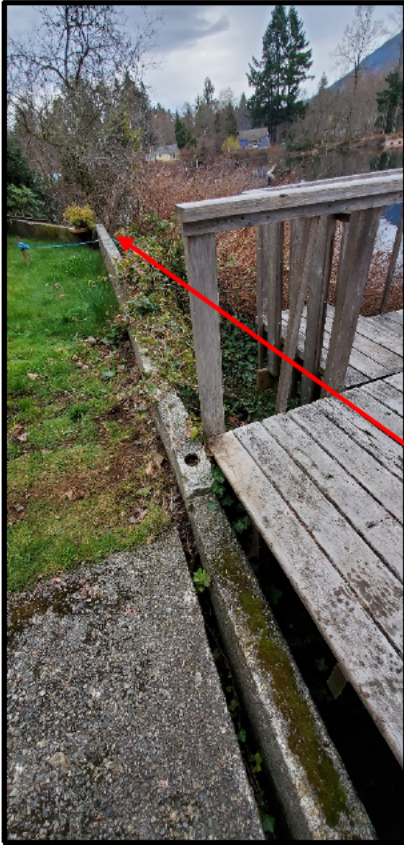
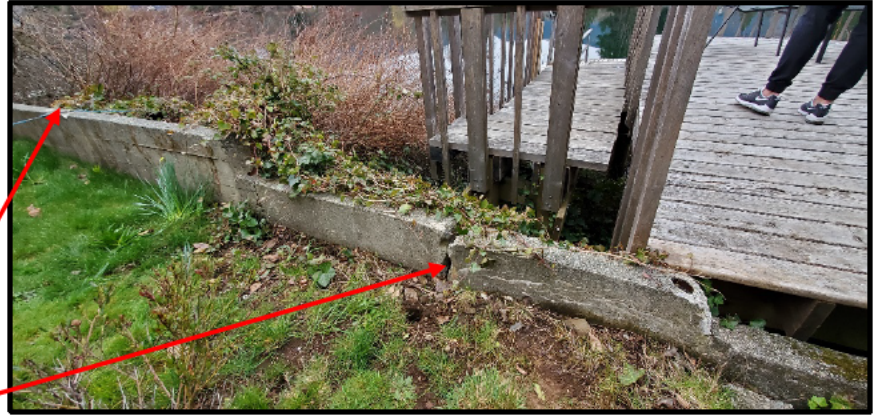
Images of cracks, separations and anchor rope.

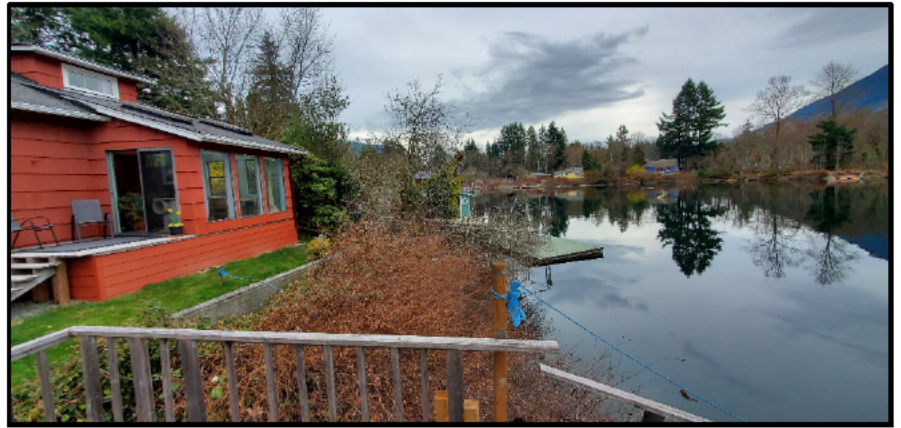
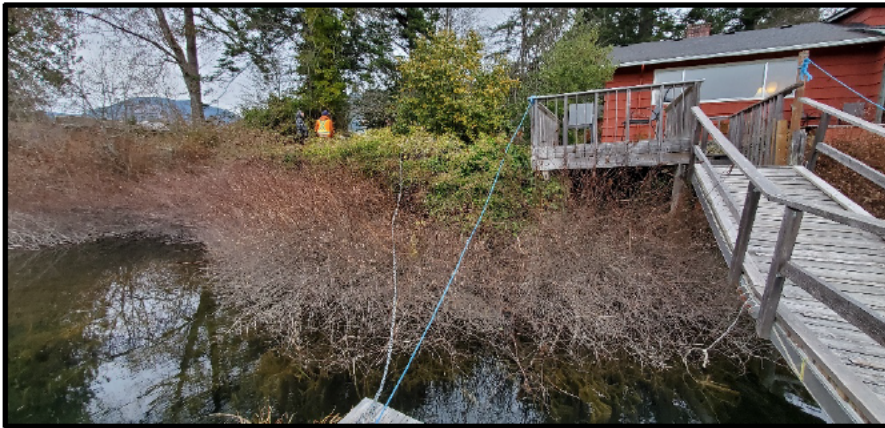
Images (above & left) of hardhack dominated riparian vegetation. Retaining wall is approx. 1.2m above bank and HWM.

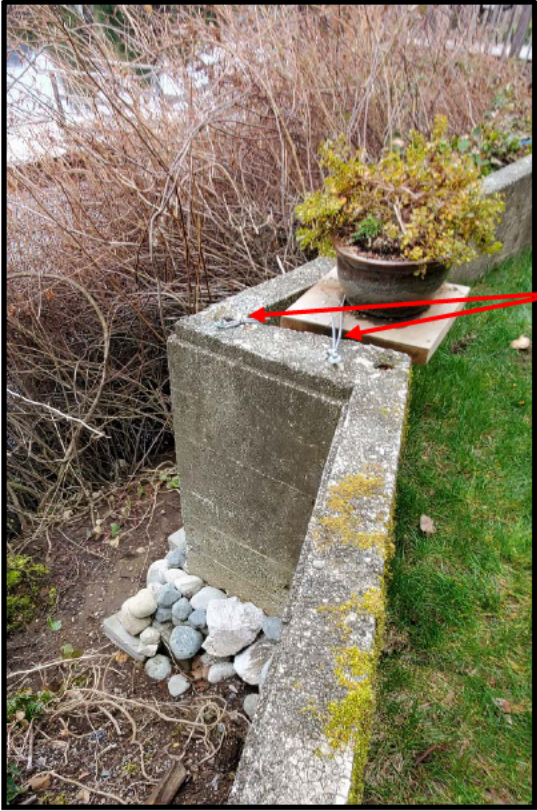
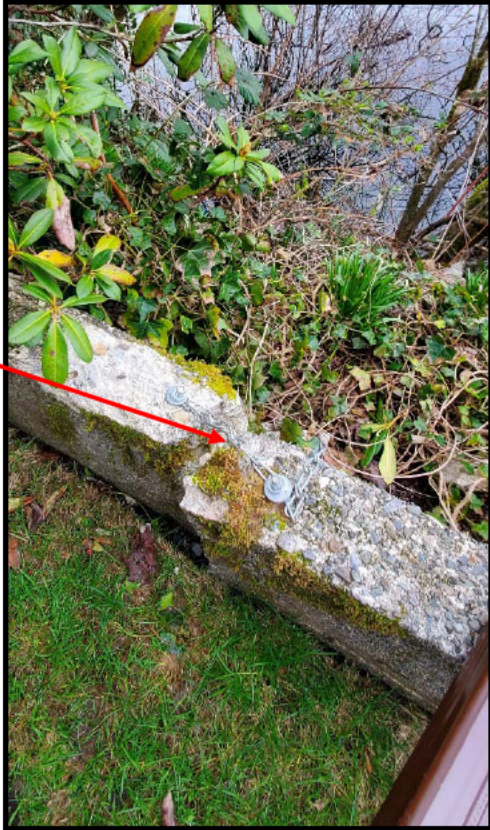
Images (Let & right) showing use of small chain and anchor bolts to keep retain wall together. Bank eroded at corner of wall.

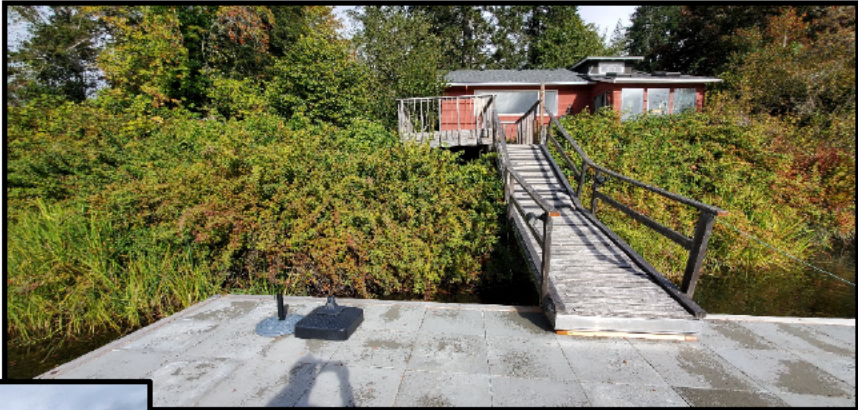
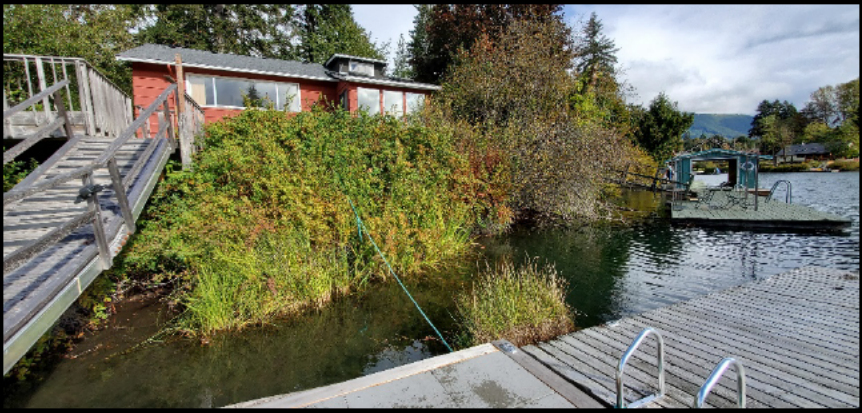
Images (Right & Below). Green-up. Dense hardhack to along existing shoreline providing good shading and shallow water cover during higher river flows.

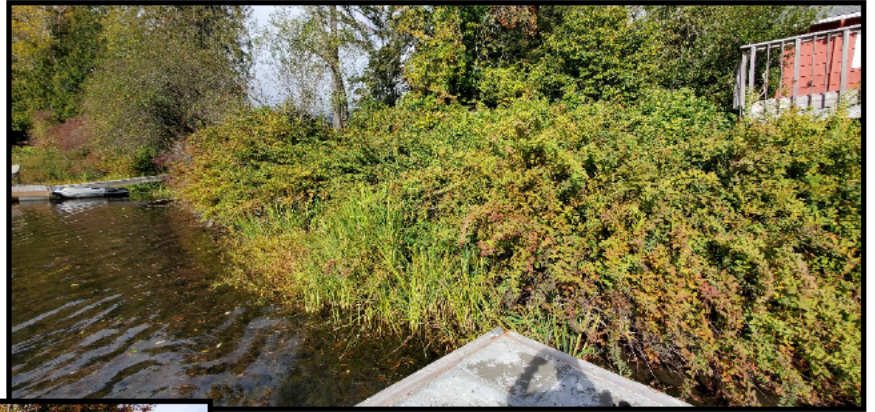
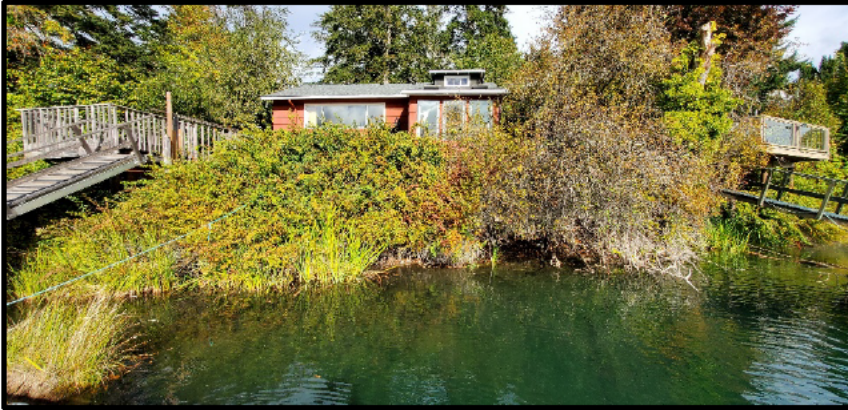
Images (Right & Below). Green-up.
Dense hardhack to along existing
shoreline providing good shading and
shallow water cover during higher river
flows. Image below shows deeper mud
bottom river section.

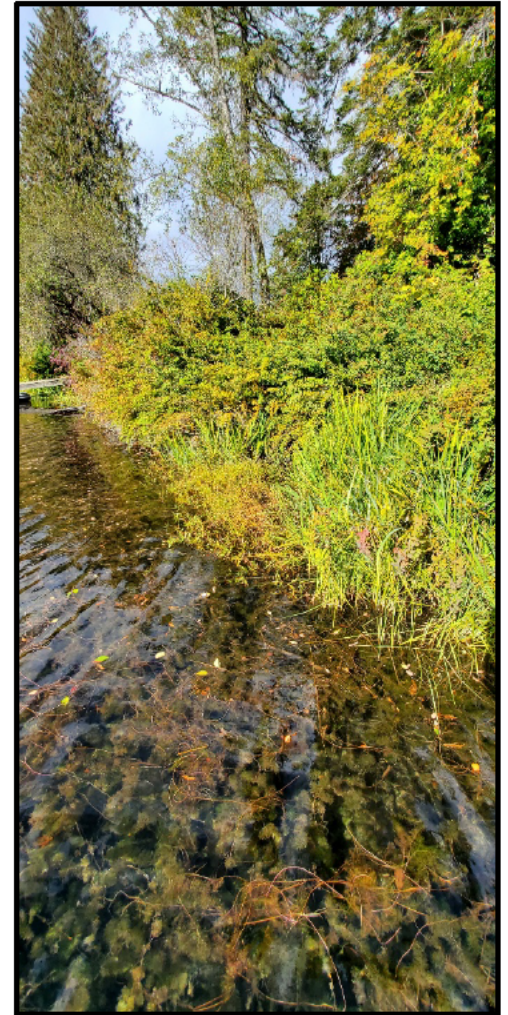
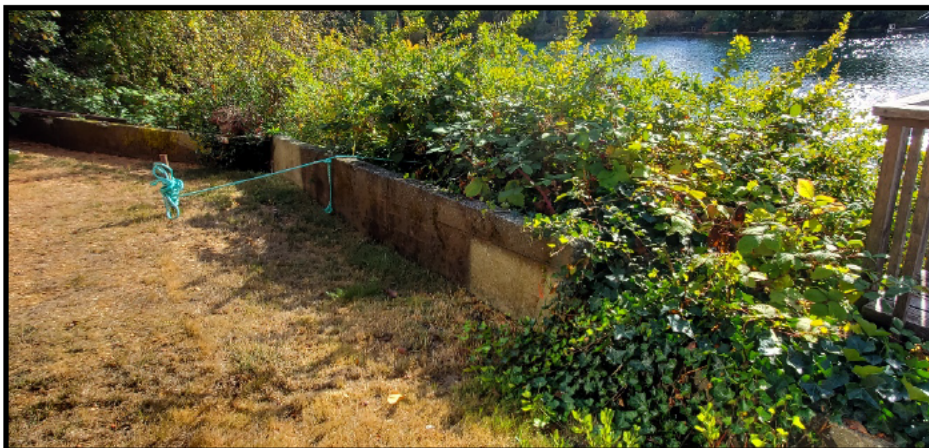
Images (Right) start of shallow
embayment with Milfoil. Image below;
rope used to anchor dock and wall.

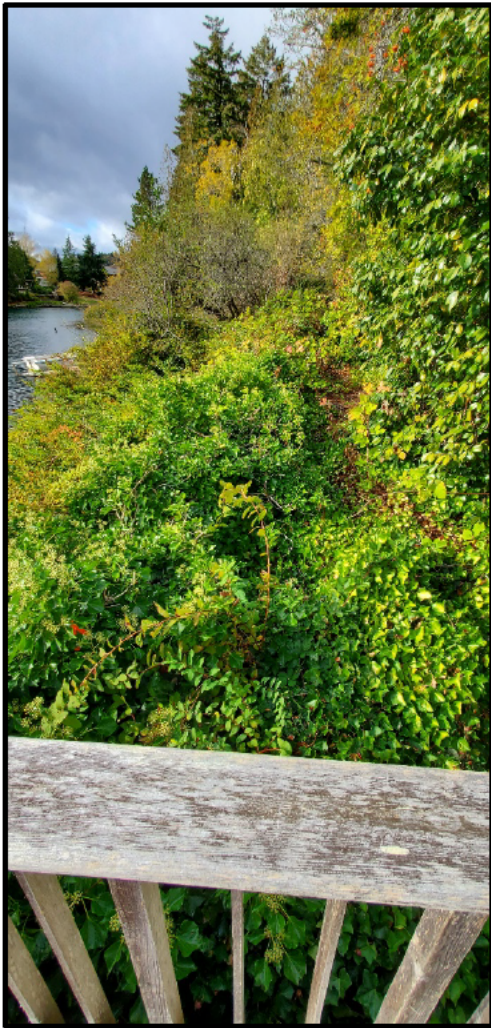
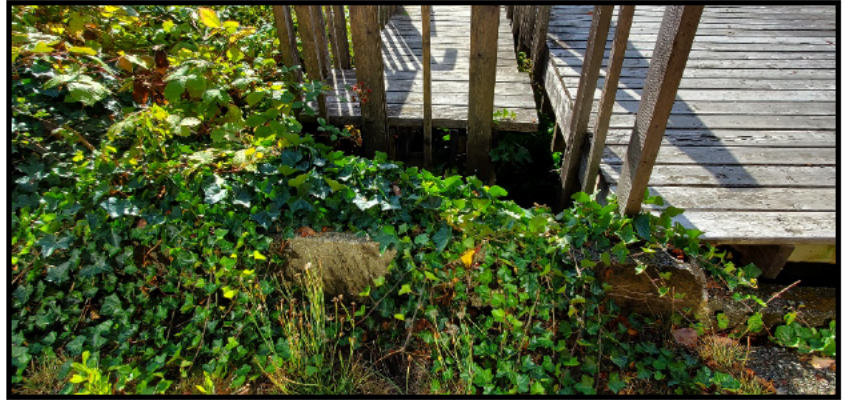
Images (above & Left) Vegetation at top of retaining wall predominately English Ivy, blackberry and hardhack. Area dominated by Invasives.

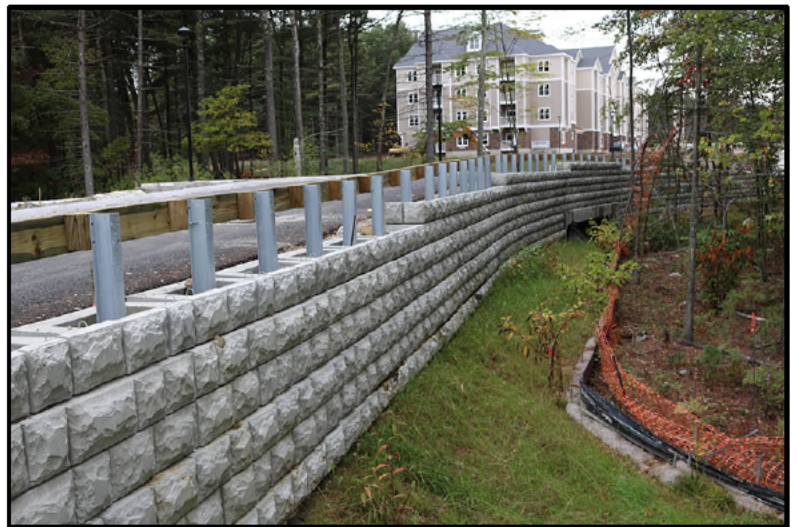
Example of stacked Verti-Block retaining use.

Design improvements to the subject properties retaining wall is provided by Ryzuk Geotechnical Engineers (Ryzuk) of Victoria BC (See Appendix B). Ryzuk proposed to construct a stacked Verti-block retaining wall as a replacement for the existing wall. The works will include removing the old retaining wall during the summer (August – September) when the Cowichan River is at its lowest and installing a precast Verti-block wall. The Verti-wall blocks have a hollow core and will be filled with 19mm minus crushed rock. Most of the existing retaining wall appears to “not” have been properly trenched in place and only install with a shallow excavation. The new retaining wall will be located immediately in front of the existing wall but along the top of bank and above the rivers high water mark (HWM). The new wall will span the width of the property and include excavating a foundation trench 1.0 to 1.5m deep, a gravel foundation pad and then stacking Verti-blocks 3-high, followed by drainage pipe (100mm perforated PVC pipe) and backfilling with gravel. The wall is expected to be at least 50cm above the height of the HWM (See Appendix B). Again, the owners are partially removing a sunroom to allow for the excavation of the foundation trench for the wall. The design will not have any influence of fish habitat and only result in short-term impacts to shoreline dominated by invasive plants. Native vegetation is expected to re-establish itself within one year.

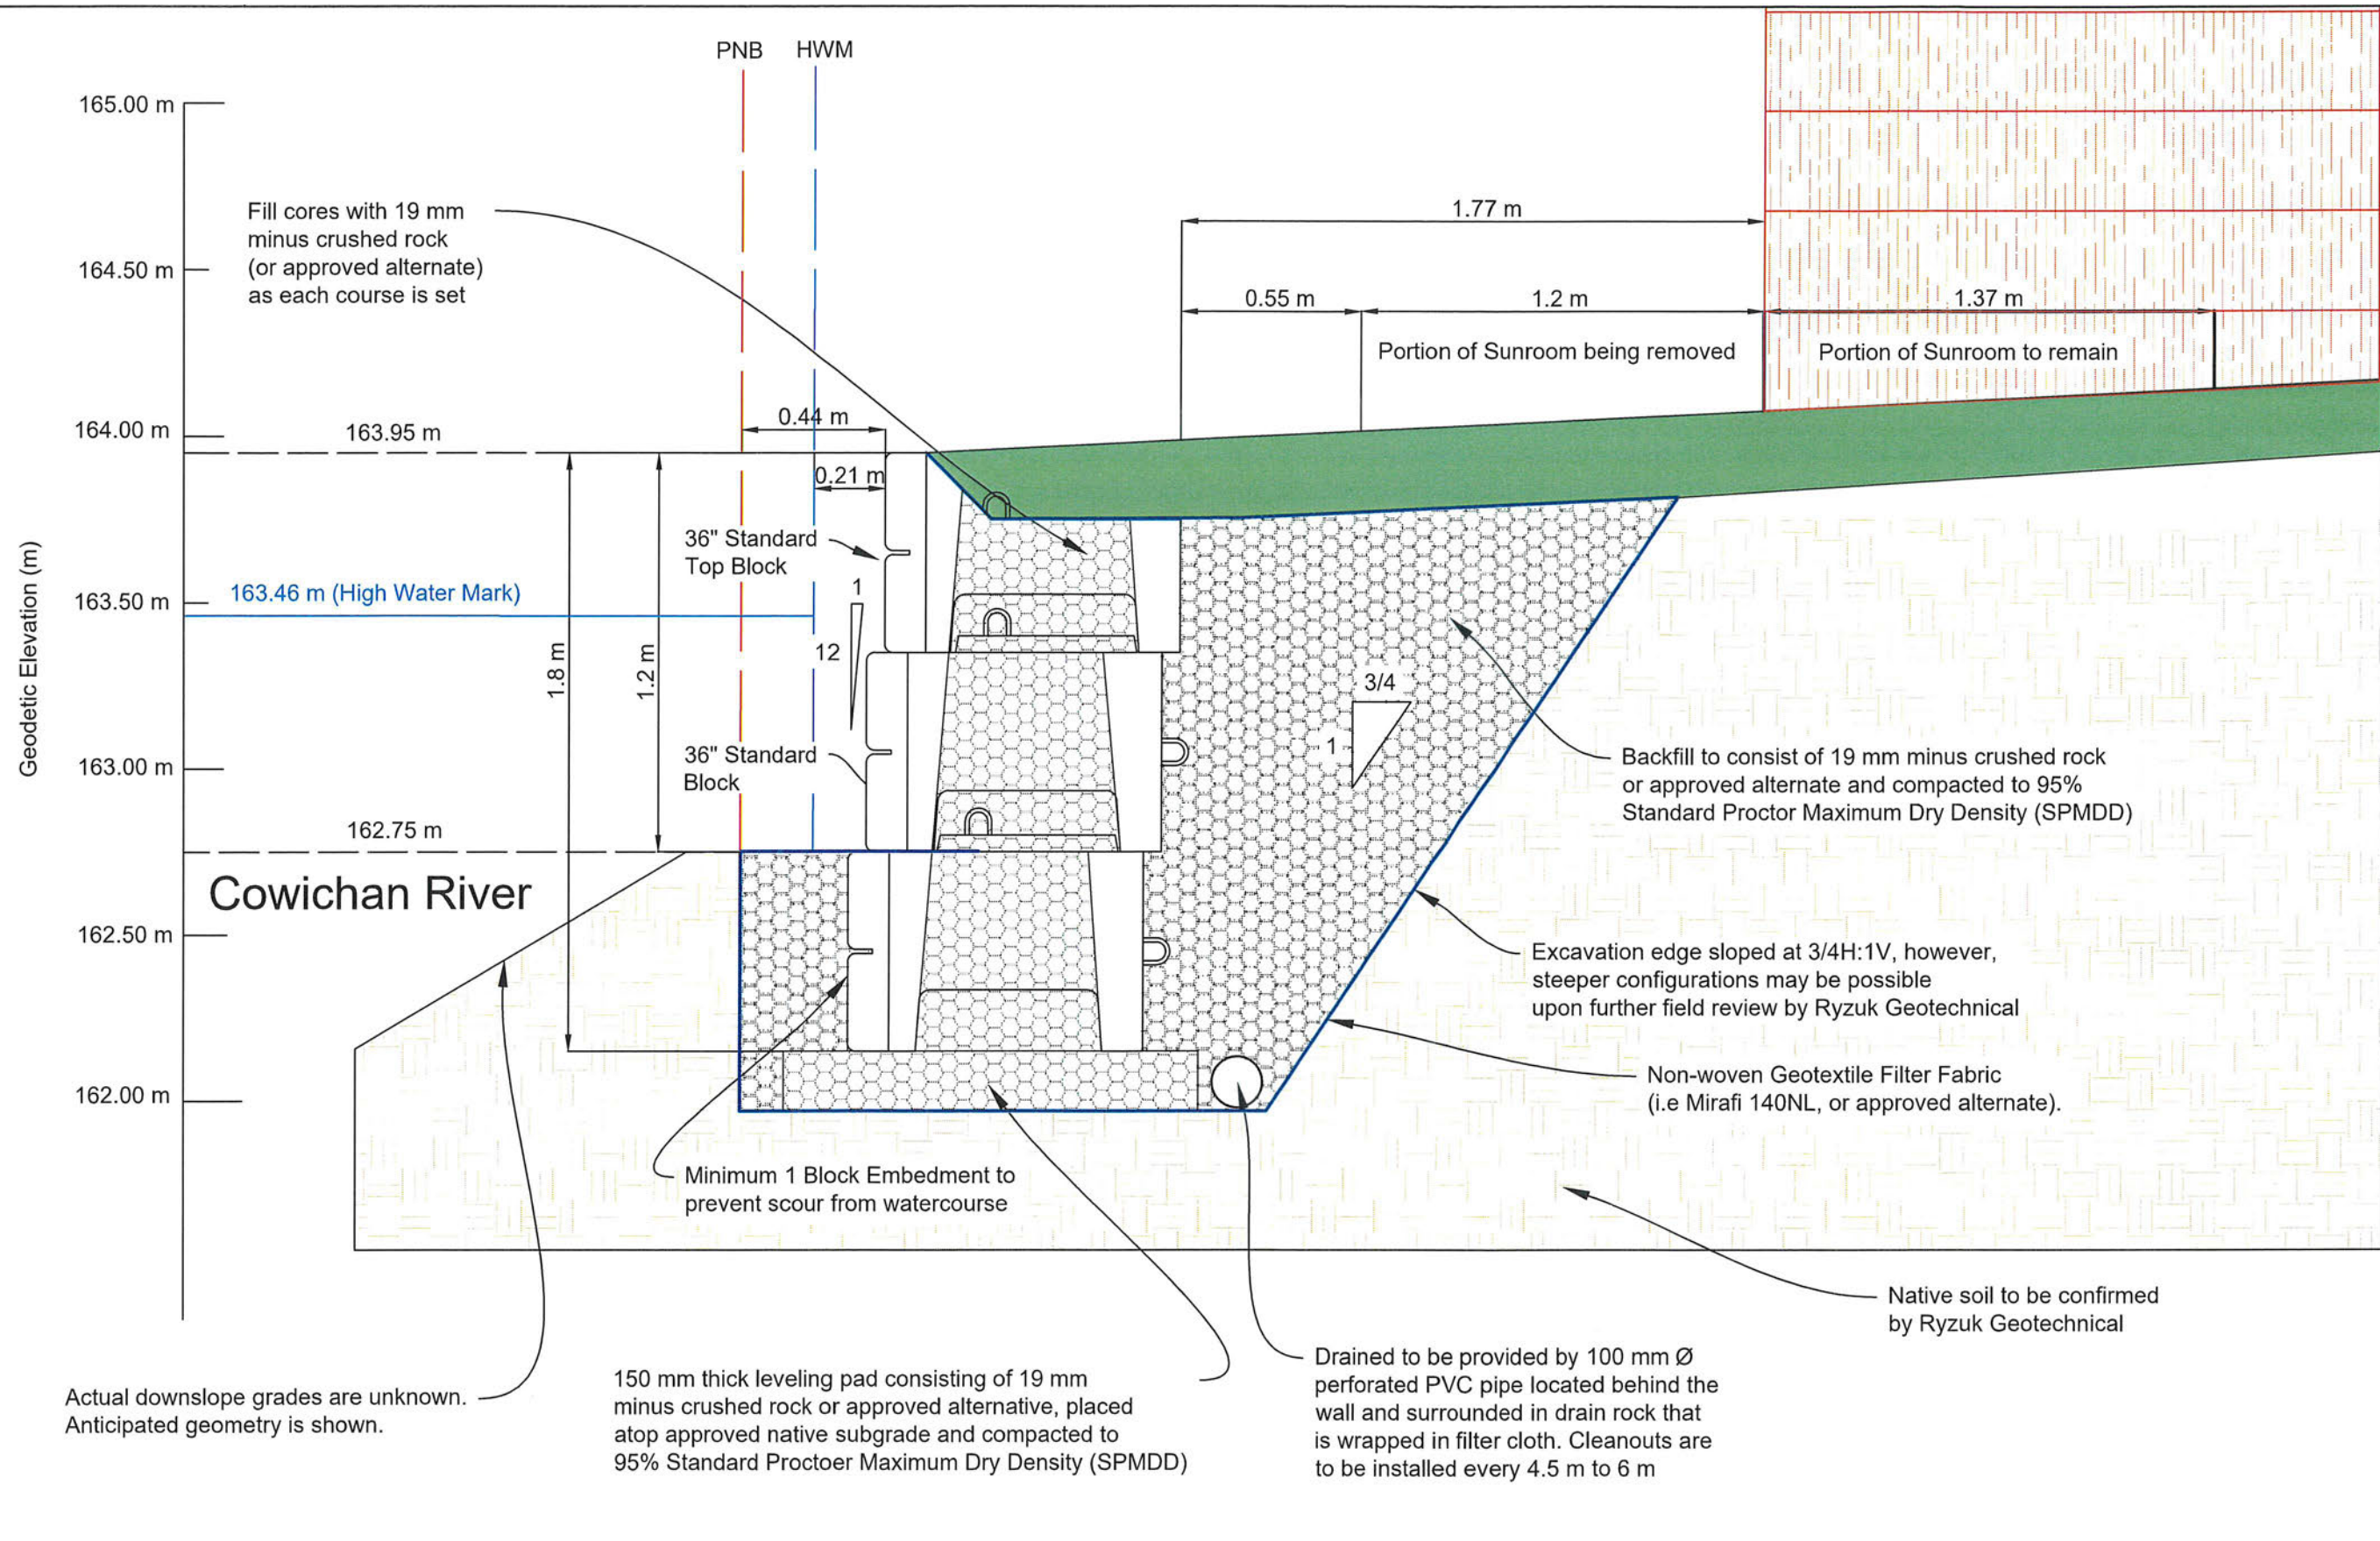
Actual downslope grades are unknown. Anticipated geometry is shown.

150 mm thick leveling pad consisting of 19 mm minus crushed rock or approved alternative, placed atop approved native subgrade and compacted to 95% Standard Proctor Maximum Dry Density (SPMDD)
